# Navigation Conditions at Point Marion Lock and Dam, Monongahela River

## Hydraulic Model Investigation

Technical Report CHL-97-30  
October 1997

U.S. Army Corps of Engineers  
Waterways Experiment Station  
3909 Halls Ferry Road  
Vicksburg, MS 39180-6199

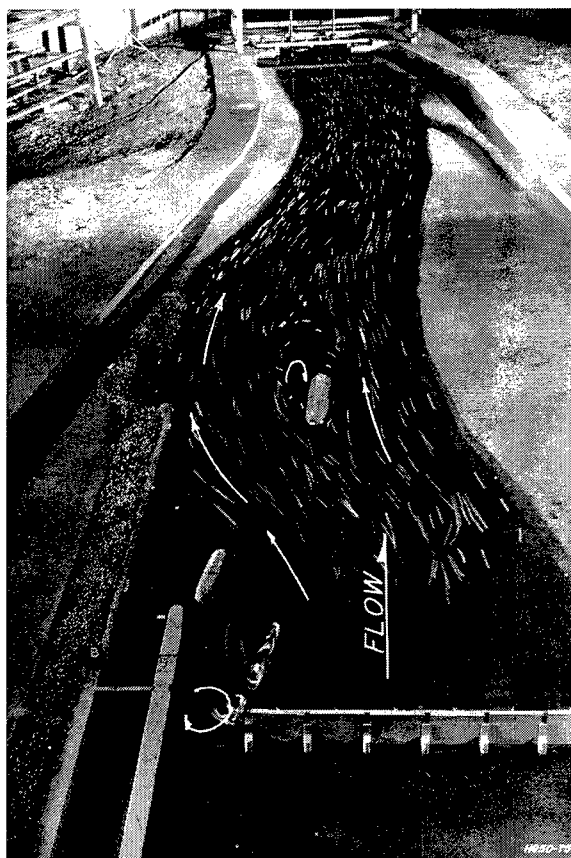
Photo 22. Plan B-Modified, looking downstream, discharge 22,500 cfs, confetti showing surface current patterns in the lower approach to the lock

**Current directions and velocities.** Current direction and velocity data shown in Plate 9 and current patterns shown in Photos 22 and 23 indicate that the flow through the spillway moved between the vane dike near the end of the riverside lock wall and the vane dike near midchannel and across the lower lock approach at a steep angle. Some flow passed through the opening between the vane dike and the downstream end of the riverside lock wall. However, a small counterclockwise eddy formed immediately downstream of the lock chamber (Plate 9). The velocity of the current in the eddy varied from less than 0.5 to about 1.7 fps with the 33,000- and 55,000-cfs riverflows, respectively. The maximum velocities of the current near the downstream end of the guide wall varied from about 3.4 to 4.0 fps with the 22,500- and 55,000-cfs riverflows,

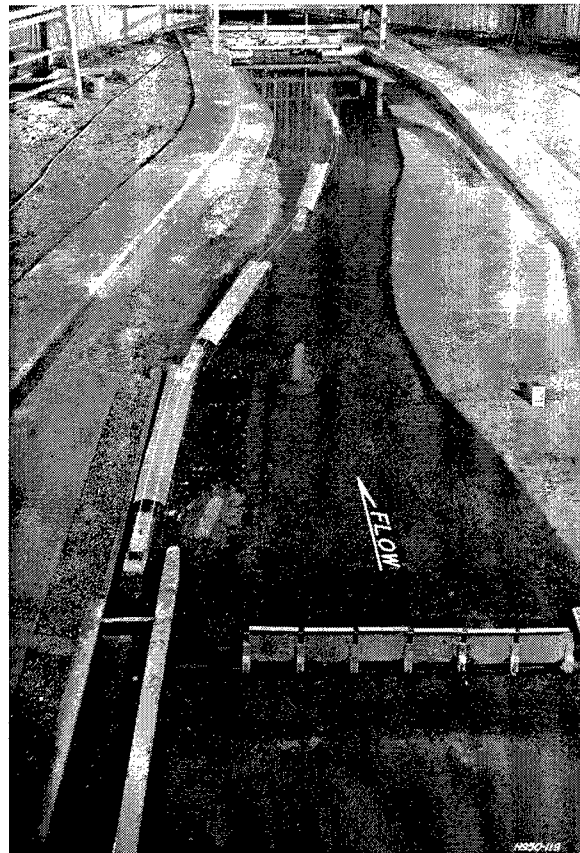
Photo 49. Plan E, looking downstream, discharge 22,500 cfs, showing path of downbound tow leaving lock

approach and enter the main channel without any difficulties (Photos 49 and 50). Maneuvering the head of the tow away from the guide wall would require additional time but was not a difficult maneuver. If the tow moved downstream without maneuvering the head of the tow off the wall, the clearance between the tow and the left bank was minimal for the tow to turn toward the main river channel. Upbound tows could leave the main river channel, align with the guide wall, and enter the lock chamber without any difficulties (Photos 51 and 52). There was no tendency for the head of the tow to move away from the guide wall as the tow entered the lock chamber.
